ADDENDUM NO. 1

To all Bidders on the Project titled: Life and Physical Science Building Abatement and Demolition Project

2012BakerEnvReport.pdf – this is a report from a 2012 asbestos survey of the Old Library Building at the COR main campus, 7351 Tompkins Hill Road, Eureka, California. The survey was conducted on January 25, 2012 by a Cal-OSHA Certified Asbestos Consultant.

asbestos survey 2004.pdf - LIMITED ASBESTOS SURVEY FOR THE COLLEGE OF THE REDWOODS PHYSICAL EDUCATION, APPLIED TECHNOLOGY/AUTOMOTIVE SHOP, CREATIVE ARTS, PHYSICAL SCIENCE, LIFE SCIENCE, OLD LIBRARY, AND FORUM BUILDINGS EUREKA, CALIFORNIA

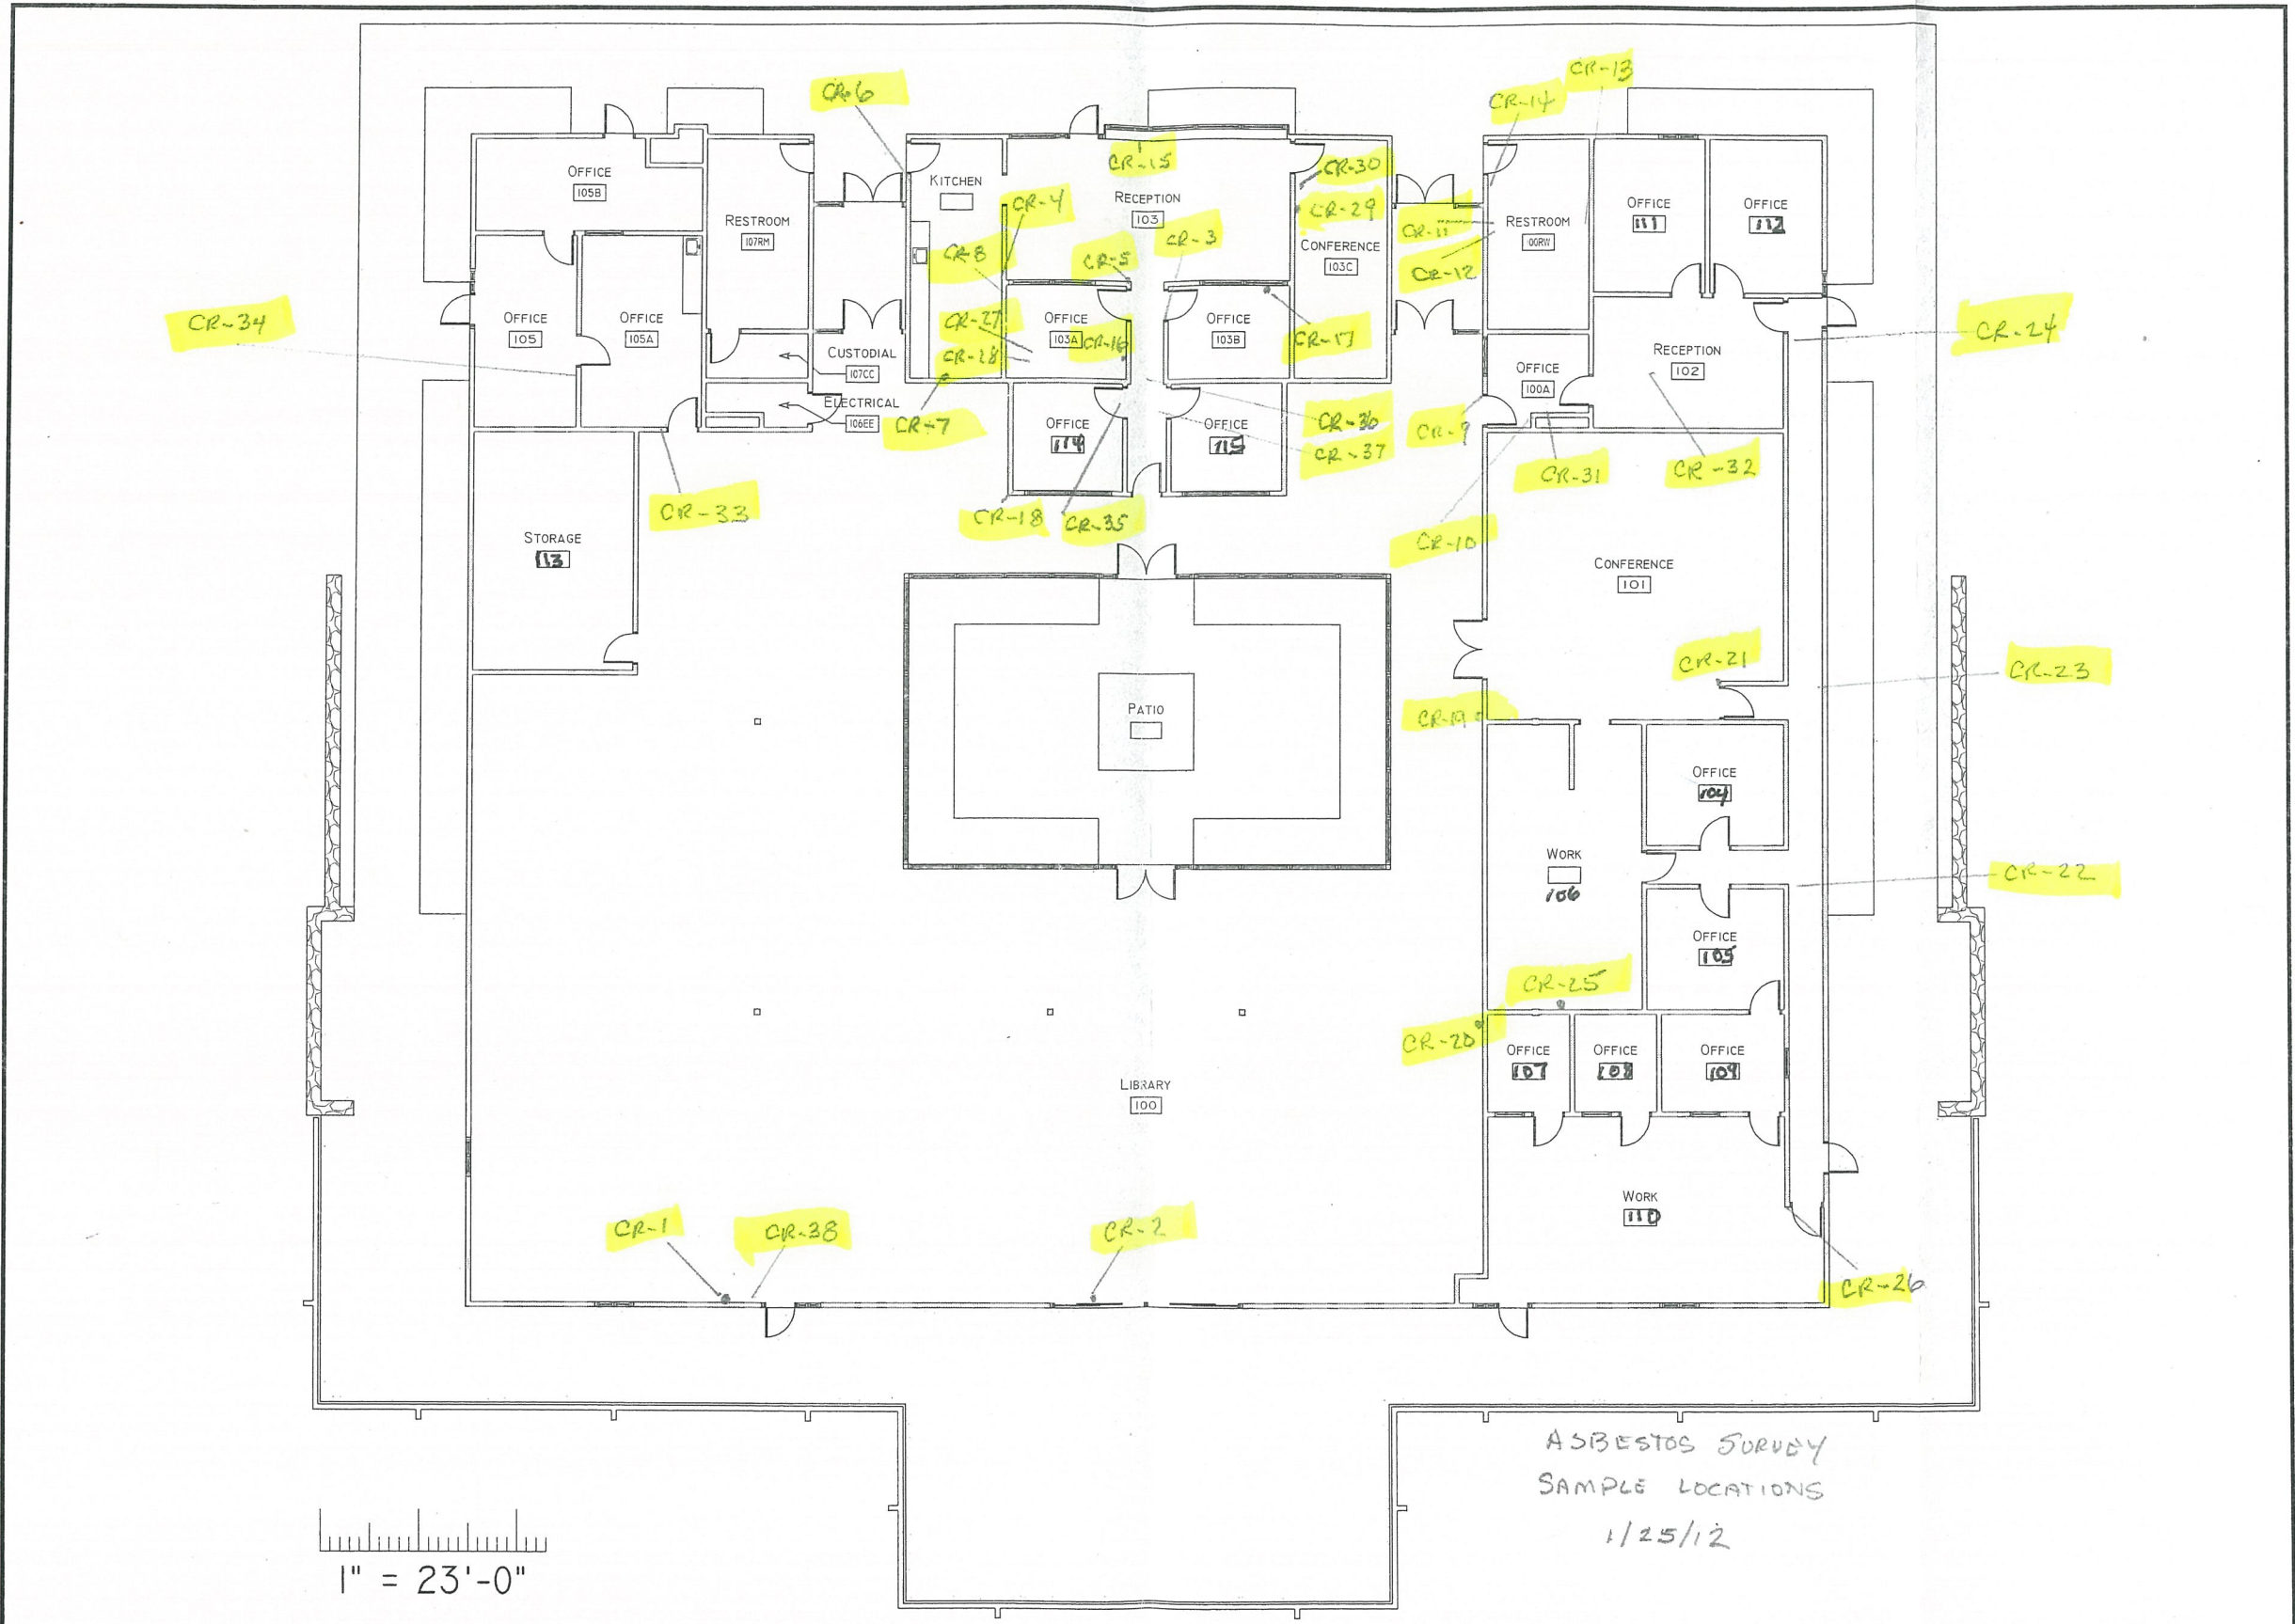
COLLEGE OF THE REDWOODS - EUREKA CAMPUS
LIBRARY BUILDING (OUT OF SERVICE)

Sample#	Space	Description	Location	%Asbestos	Friable	Quantity¹
CR-1 to CR-10 CR-13,CR-14 CR-28,CR-30 CR-31,CR-33	Throughout Bldg. (Original Construction)	Drywall joint compound	Walls/ceilings	2-3	No	Throughout
CR-3 to CR-10 CR-13, CR-14	Restrooms, Kitchen Custodial, Office 100A	Drywall texture/skim coats	Walls	2-3	Yes	Throughout
N/A	Restrooms, Custodial 103 Kitchen, Misc. Locations	Thermal system insulation	Walls/ceilings	Assumed	Yes	Throughout

The areas of the Old Library Building with asbestos-containing thermal system insulation and drywall skim coat must be removed, transported and disposed as hazardous wastes in California. Said transportation and disposal must be in accordance with State of California regulations that require hazardous waste manifests and approved disposal sites. The remaining RACM including drywall joint compound must be transported to and disposed at a state approved disposal site.

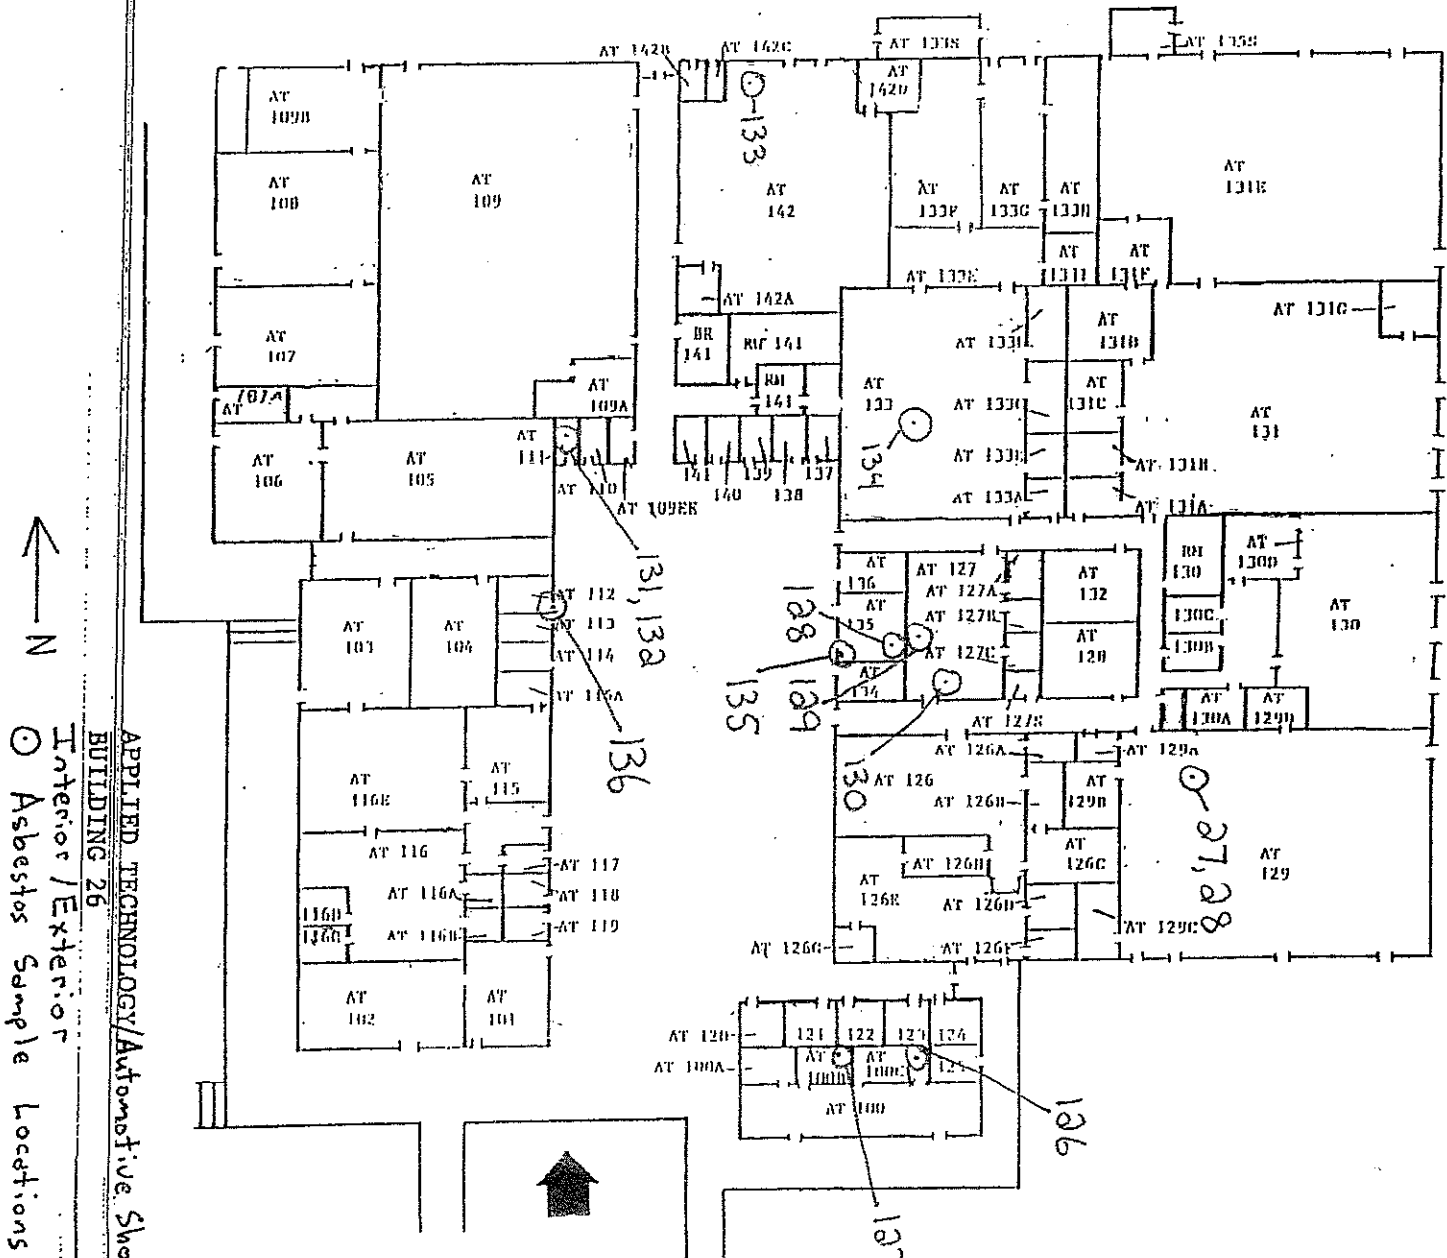
Figure 3

APPLIED TECHNOLOGY/Automotive Shop
 BUILDING 25
 Interior / Exterior
 ○ Asbestos Sample Locations

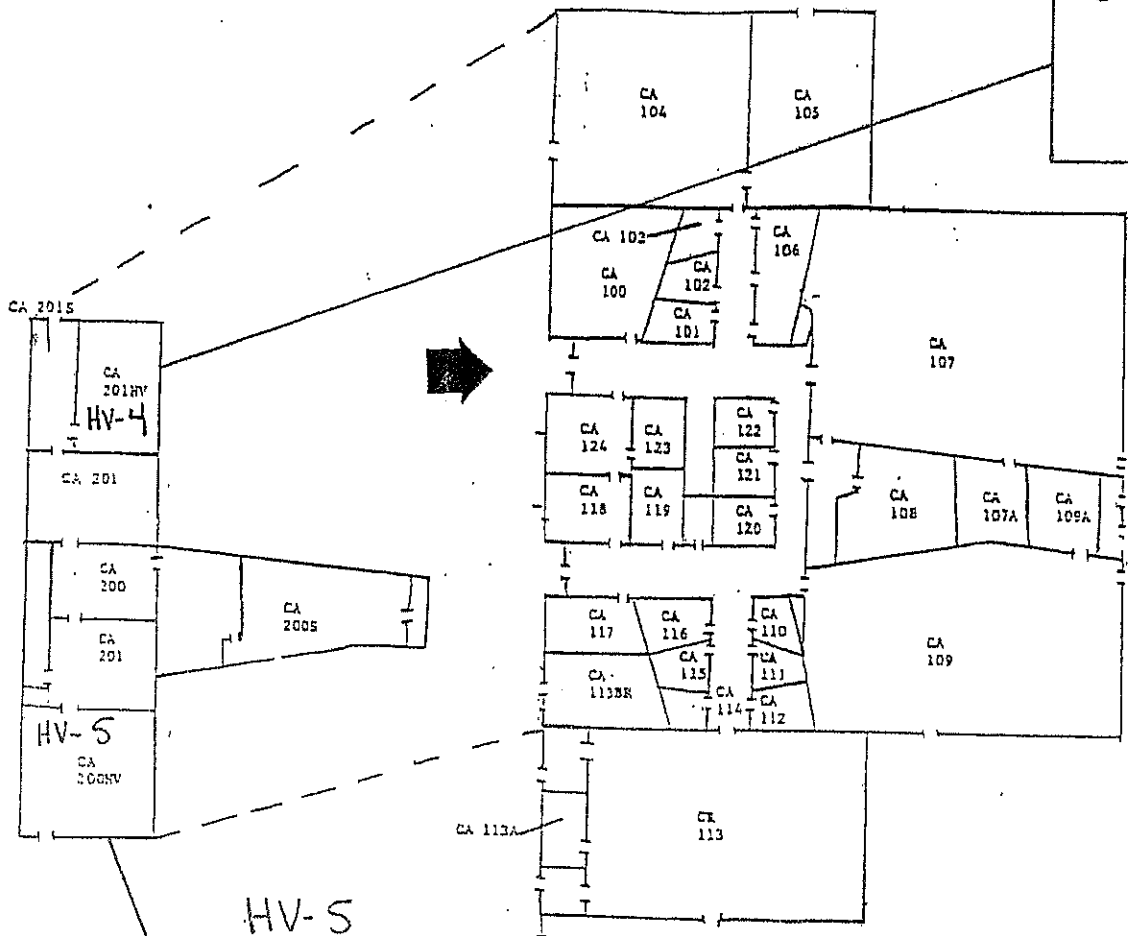
Figure 4

CREATIVE ARTS
 BUILDING 02
 Interior
 ○ Asbestos Sample Locations

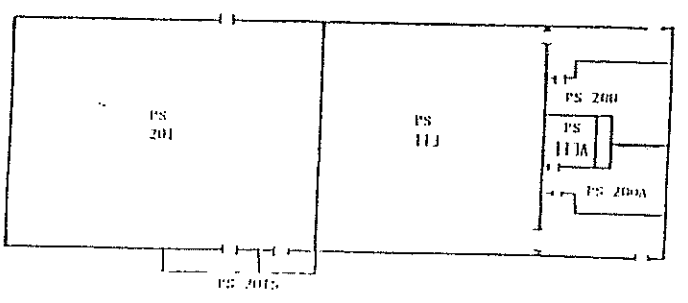
Figure 6

PHYSICAL SCIENCE
 BUILDING 10
 Exterior
 ○ Asbestos Sample Location

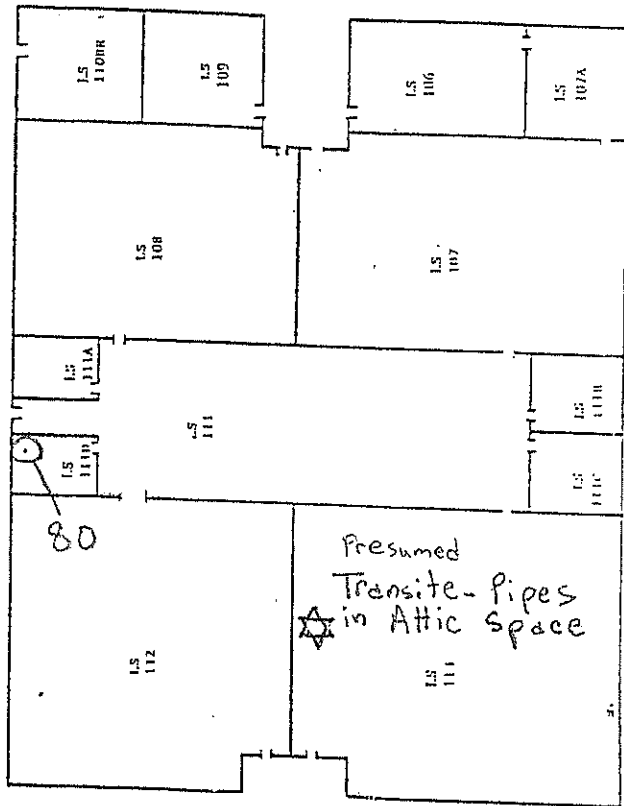
Figure 7

LIFE SCIENCE
 BUILDING 12
 Exterior
 ○ Asbestos Sample Locati

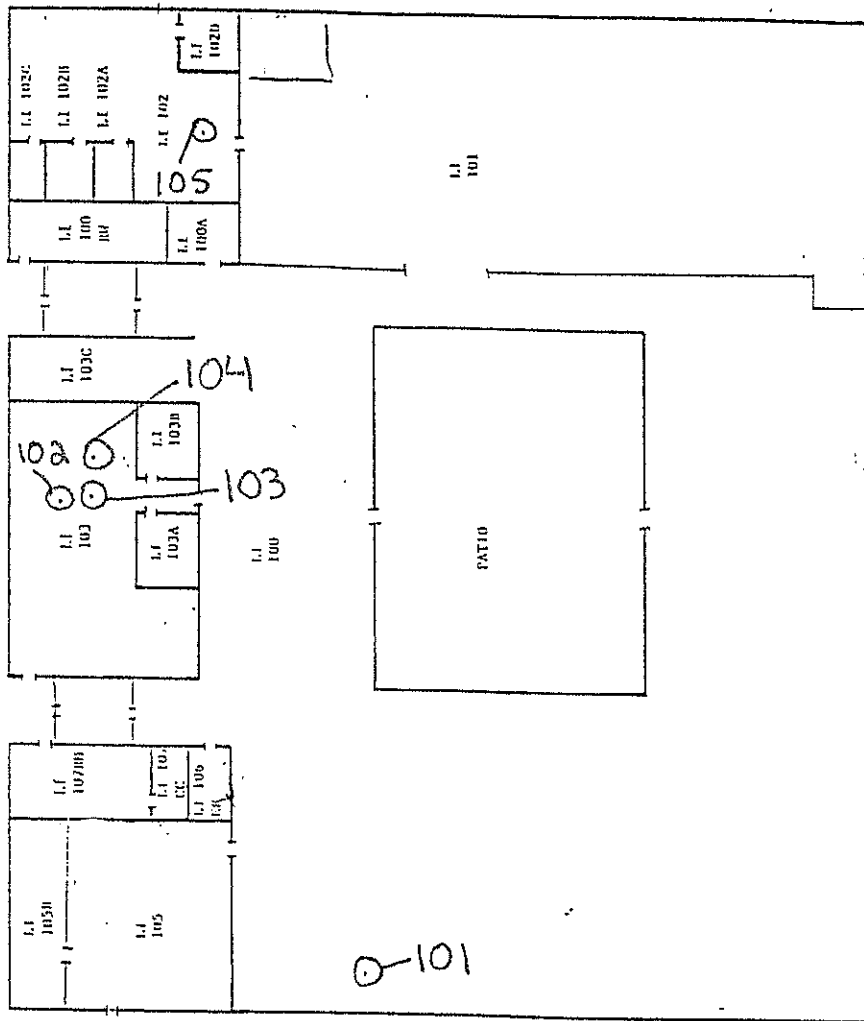
Figure 8

← N
 LIBRARY
 BUILDING 14
 Exterior
 ○ Asbestos Sample Location

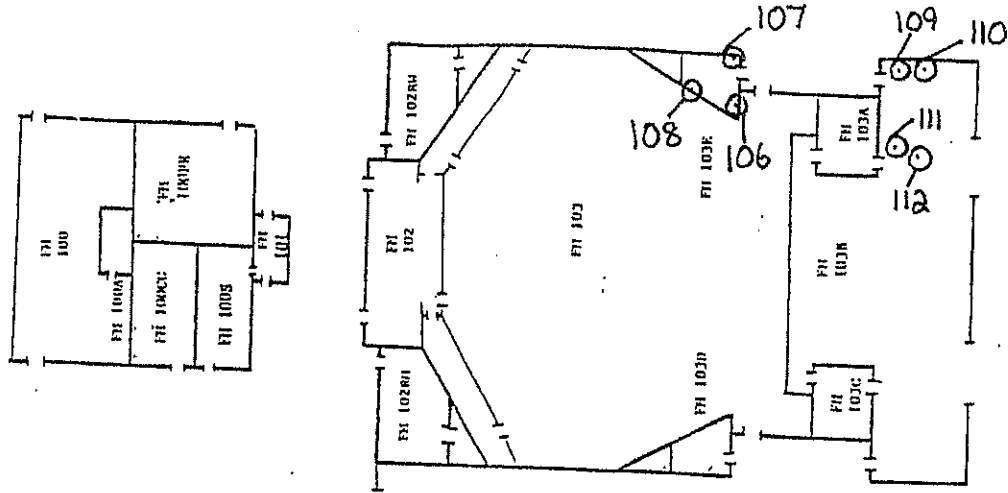
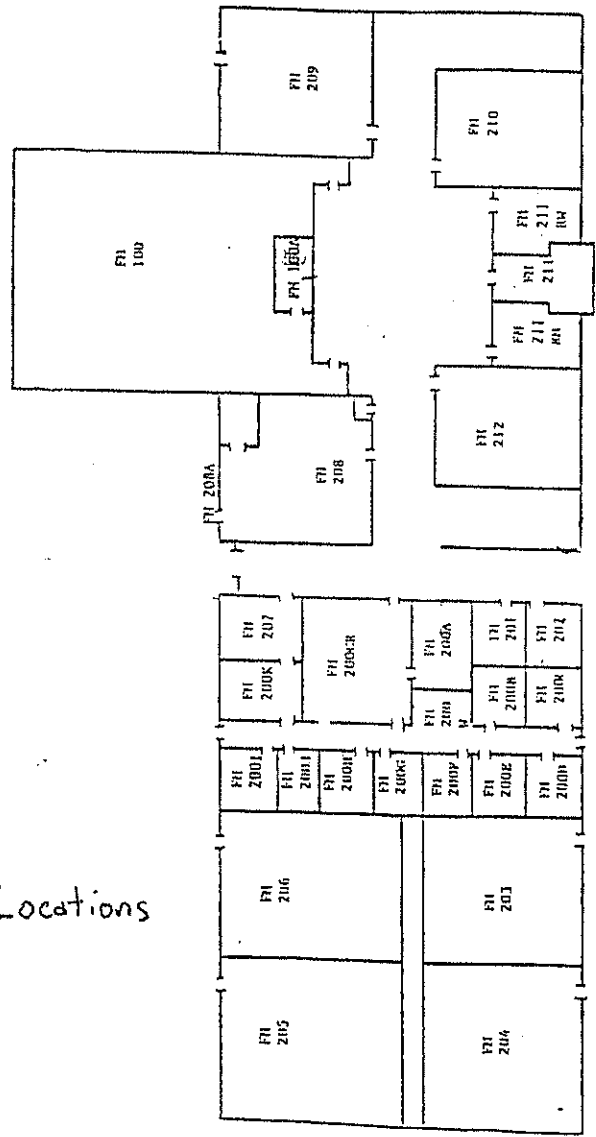
Figure 9

FORUM
BUILDING 16
Interior
○ Asbestos Sample Locations

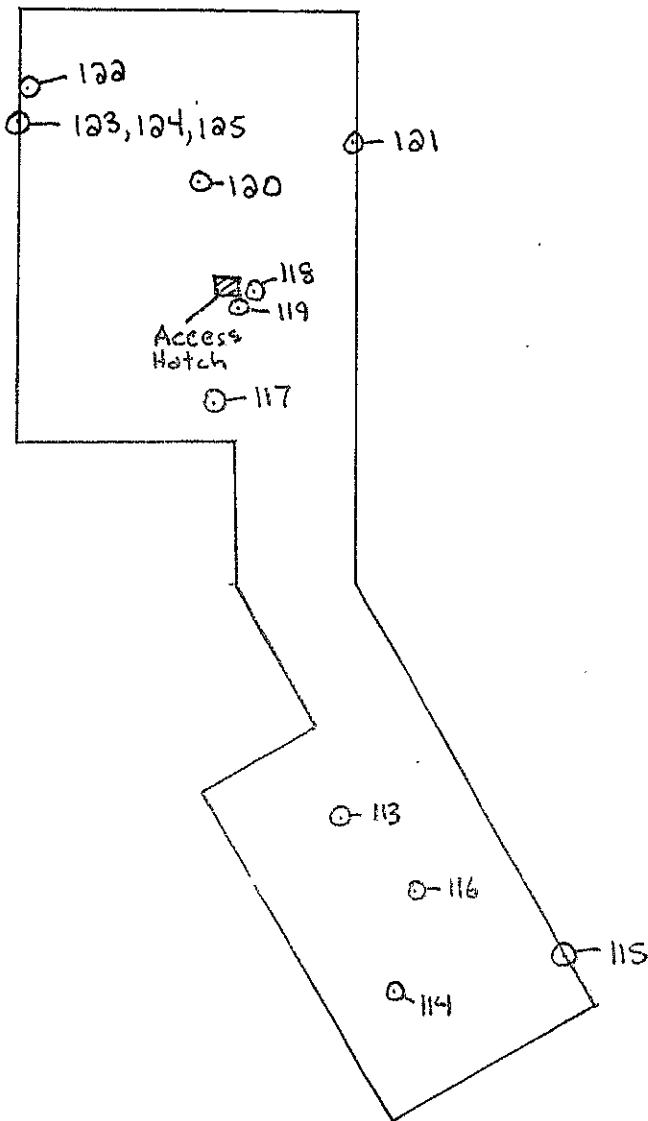
Forum
Exterior
○ Asbestos Sample Locations
